NIST NCSTAR 1-5A

**Federal Building and Fire Safety Investigation of
the World Trade Center Disaster**

Visual Evidence, Damage Estimates, And Timeline Analysis

William M. Pitts
Kathryn M. Butler
Valentine Junker

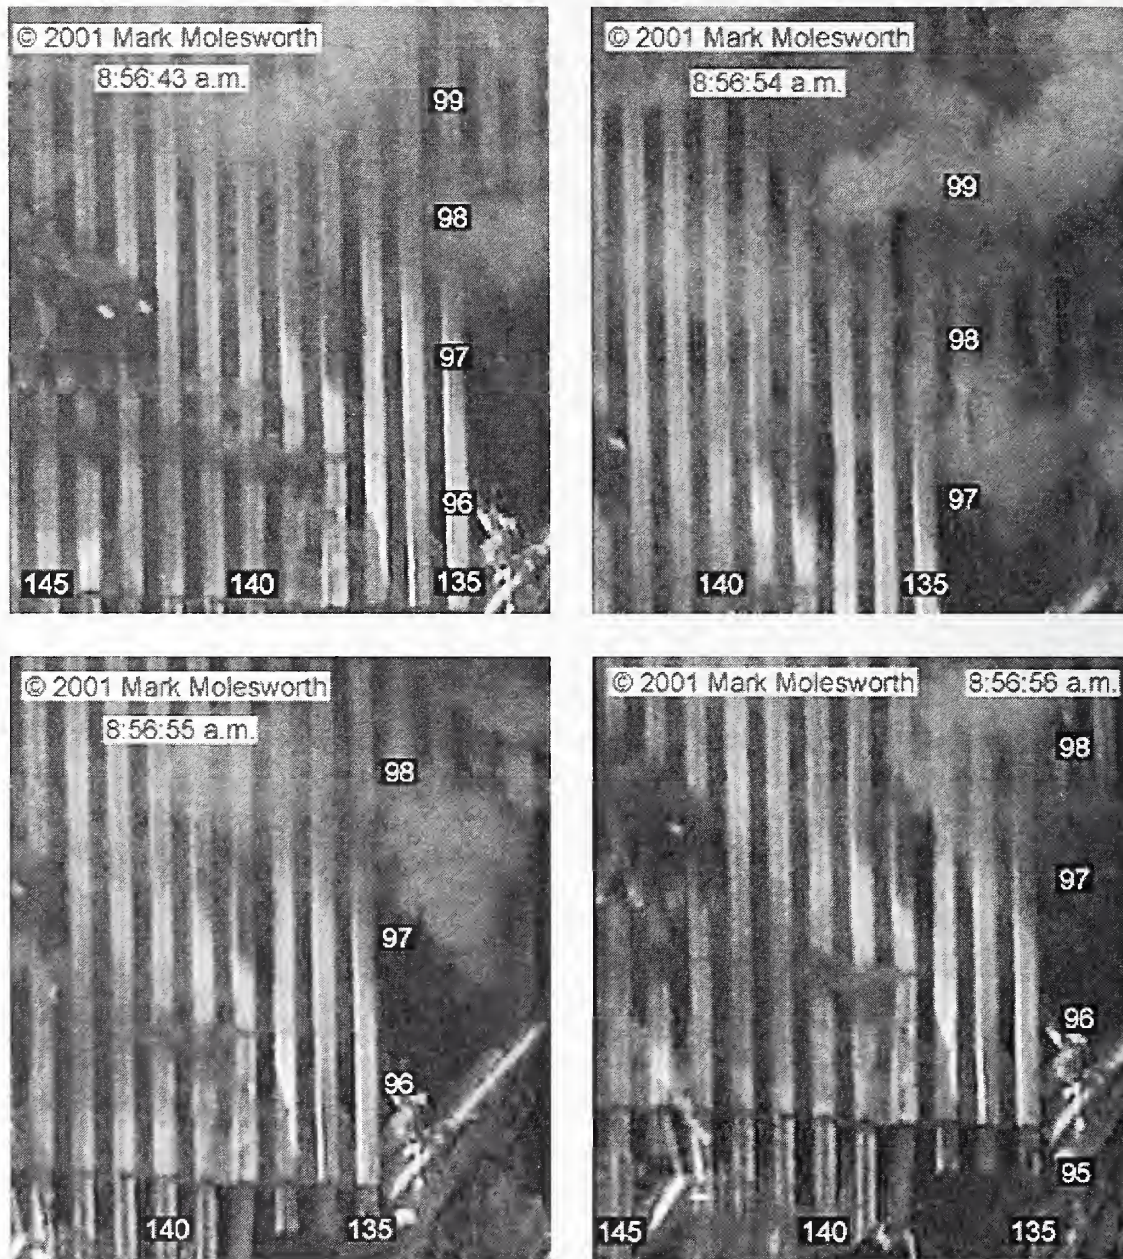
Figure 5-8 shows a series of four frames taken from a video that recorded the formation of a streamer on the north face of WTC 1. At 8:56:43 a.m. two small areas of flame are visible at the tops of windows 97-142 and 97-143. At 8:56:54 a.m. the flame at the top of window 97-142 was still in place (note that window 97-143 was out of the frame at this point). Very shortly afterward, the flame at the top of window 97-142 began to fall. The frame at 8:56:55 a.m. was taken 1.2 s later. The flaming object can now be seen near the base of window 97-142. This object extinguished very rapidly and formed the streamer that is visible curving downward at 8:56:56 a.m. near the base of the 96th floor. Note that the area of fire at the top of window 97-143 is still in place.

flames are visible on top of these lines, while in others only the lines are apparent. A likely explanation for these observations is that the thin lines are the edges of aluminum head casings that have dropped down from above the windows and that the fires seen above the lines are burning on the polyurethane located above the head casing. The large number of isolated fires seen at the tops of windows suggests that the polymer burned for a period of time before falling and forming streamers.

Figure 5-8. A series of four cropped frames from a video were recorded during the period when an isolated area of fire at the top of window 97-142 on the 97th floor dropped and formed a streamer. The intensity levels have been adjusted. Column and floor numbers have been added.

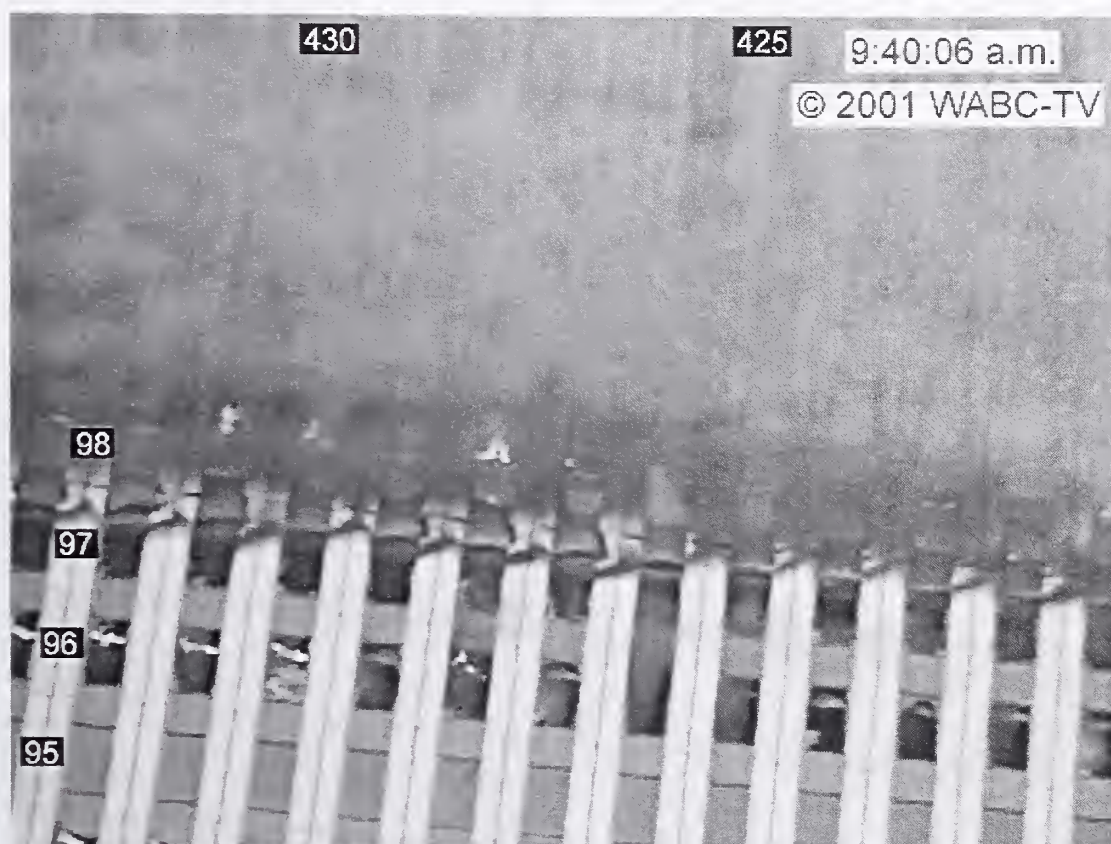
Relatively small fires at the tops of windows, such as those in Figure 5-8, were a common feature when active burning was present near the outer walls and the aluminum façade was intact. Such fires were often the only flames visible in a given window. Figure 5-9 shows a frame taken from a video in which a number of such fires burning on the 96th and 98th floors of the west face of WTC 1 are visible. As discussed in Section 8.5, the fires on this floor appeared to burn with low intensity. Nevertheless, the material at the tops of the window was exposed and ignited.

In Section 4.2.2, it was noted that polyurethane was used to thermally insulate the areas above the aluminum head casings located just inside and above the windows. Polyurethane is a flammable polymeric material that is easily ignited. It is likely that the high-temperature gases generated by nearby fires either first ignited the polyurethane above the head casing, which, in turn, resulted in the head casing dropping down to expose the burning material, or first caused the head casing to drop down, exposing the polyurethane, which was then ignited. For either scenario the result is the same, a substantial area of flaming polyurethane becomes exposed near the top of the window. In Figure 5-9, a number of what appear to be thin lines are visible near the top of windows on the 96th and 98th floor. In some cases

Figure 5-9. This close up view of the west face of WTC 1 was captured from a video recorded at 9:40:06 a.m. It has been enhanced by adjusting the intensity levels. Column and floors numbers have been added.

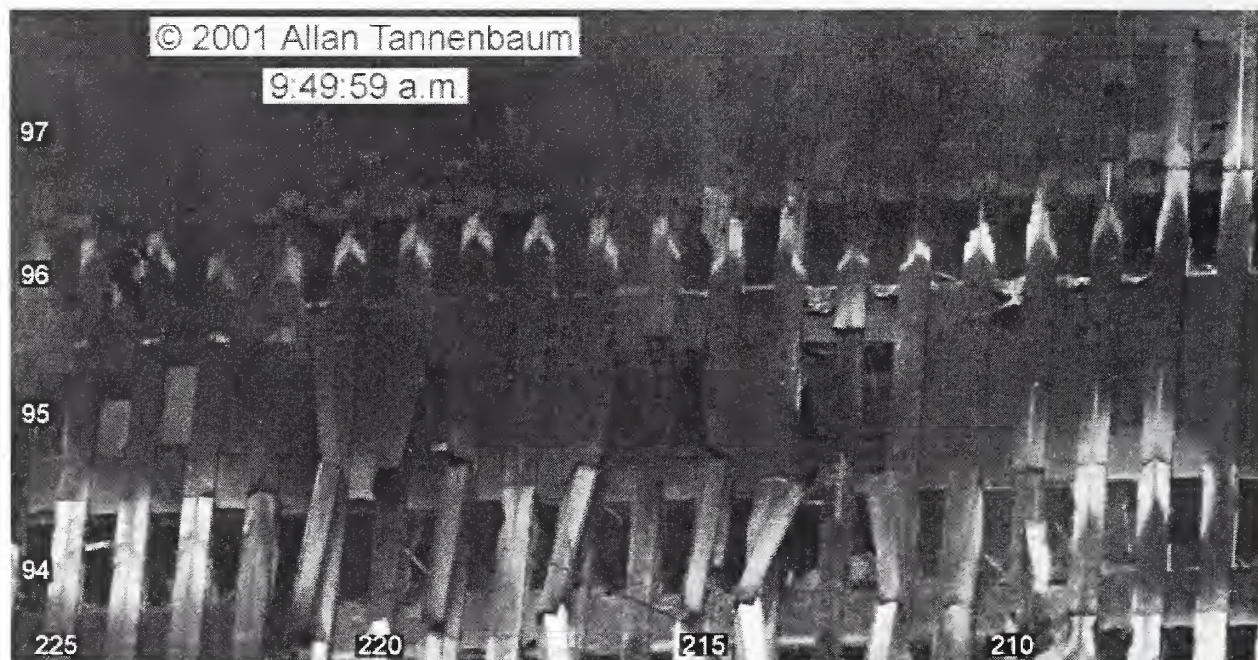
exiting a window. This flow pattern resulted in the formation of distinct patterns on the columns near the base of the burning flow that were easily identified. The marks resulted from deposited soot on the underside of the flames. Due to their shapes, this type of column pattern will be referred to as a “caret.” Figure 5–10 shows examples of carets observed on the 96th floor of the east face of WTC 1. Variations in the heights of the patterns are evident from window to window. The location of a caret on a column cover provides an indication for the distance between the top of the window and the lower region of the burning gases leaving the window. This, in turn, reflects the depth of the layer of rich combustion gases behind the window. Typically, a deeper layer corresponds to a local region of higher combustion gas formation and temperature and generally indicates a location of more intense burning.

Figure 5-10. This cropped photograph shows a portion of the east face of WTC 1 at 9:49:59 a.m. The image has been rotated and enhanced by adjusting the intensity levels. A number of carets are visible near the tops of windows on the 96th floor. These carets were created during periods of external flaming from adjacent open windows. Column and floor numbers have been added.

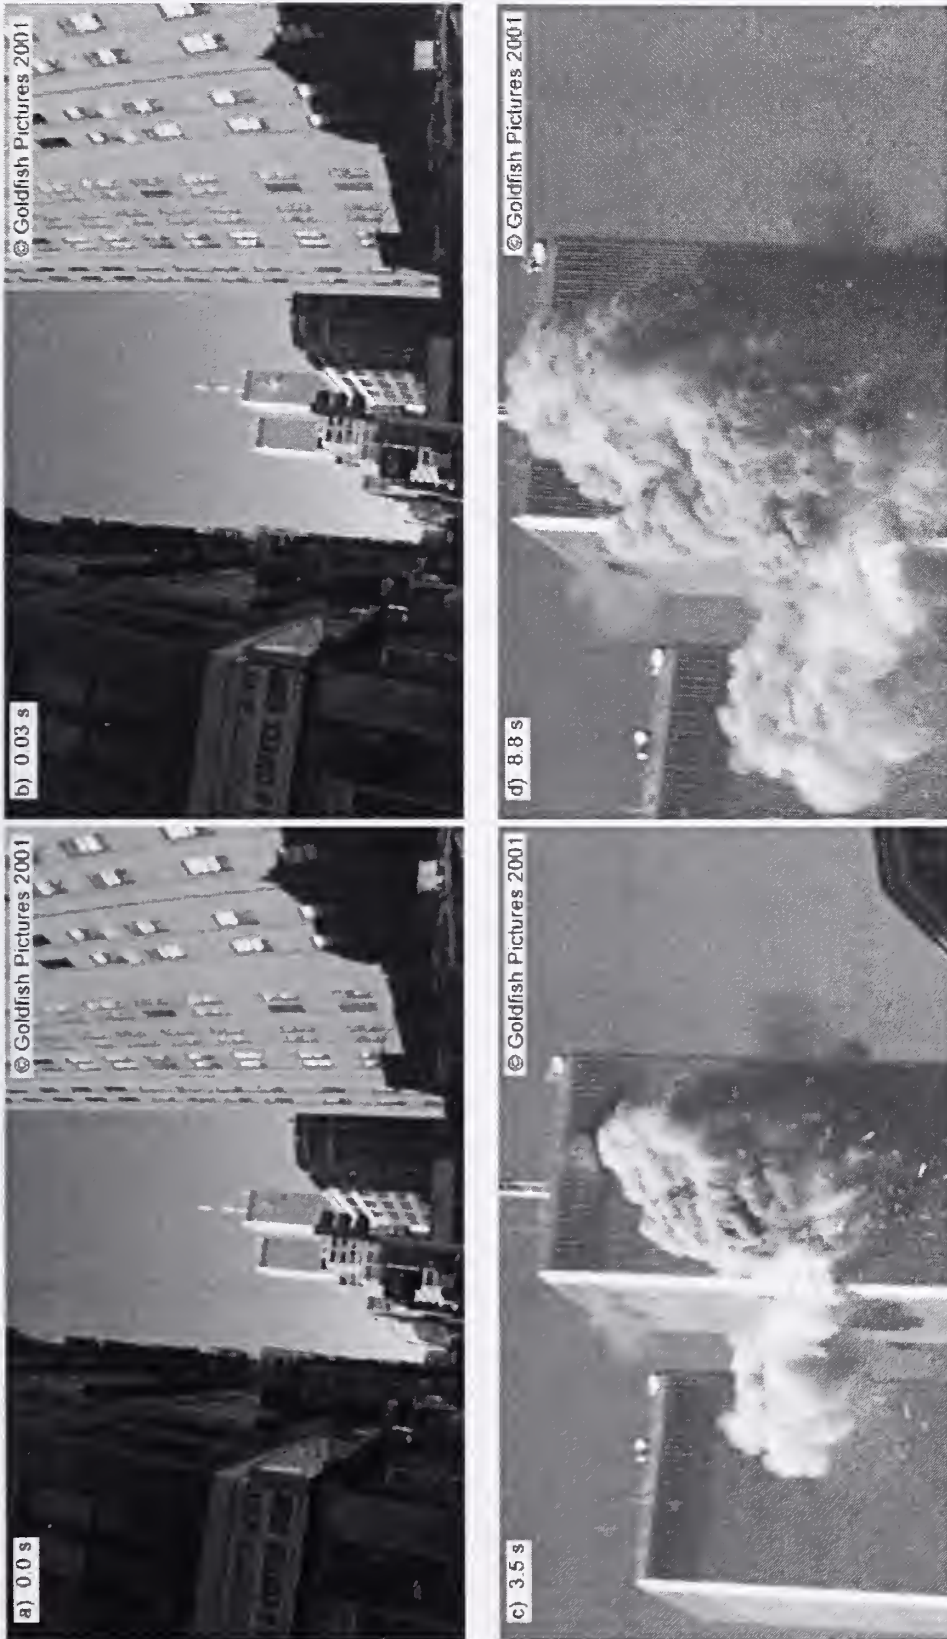
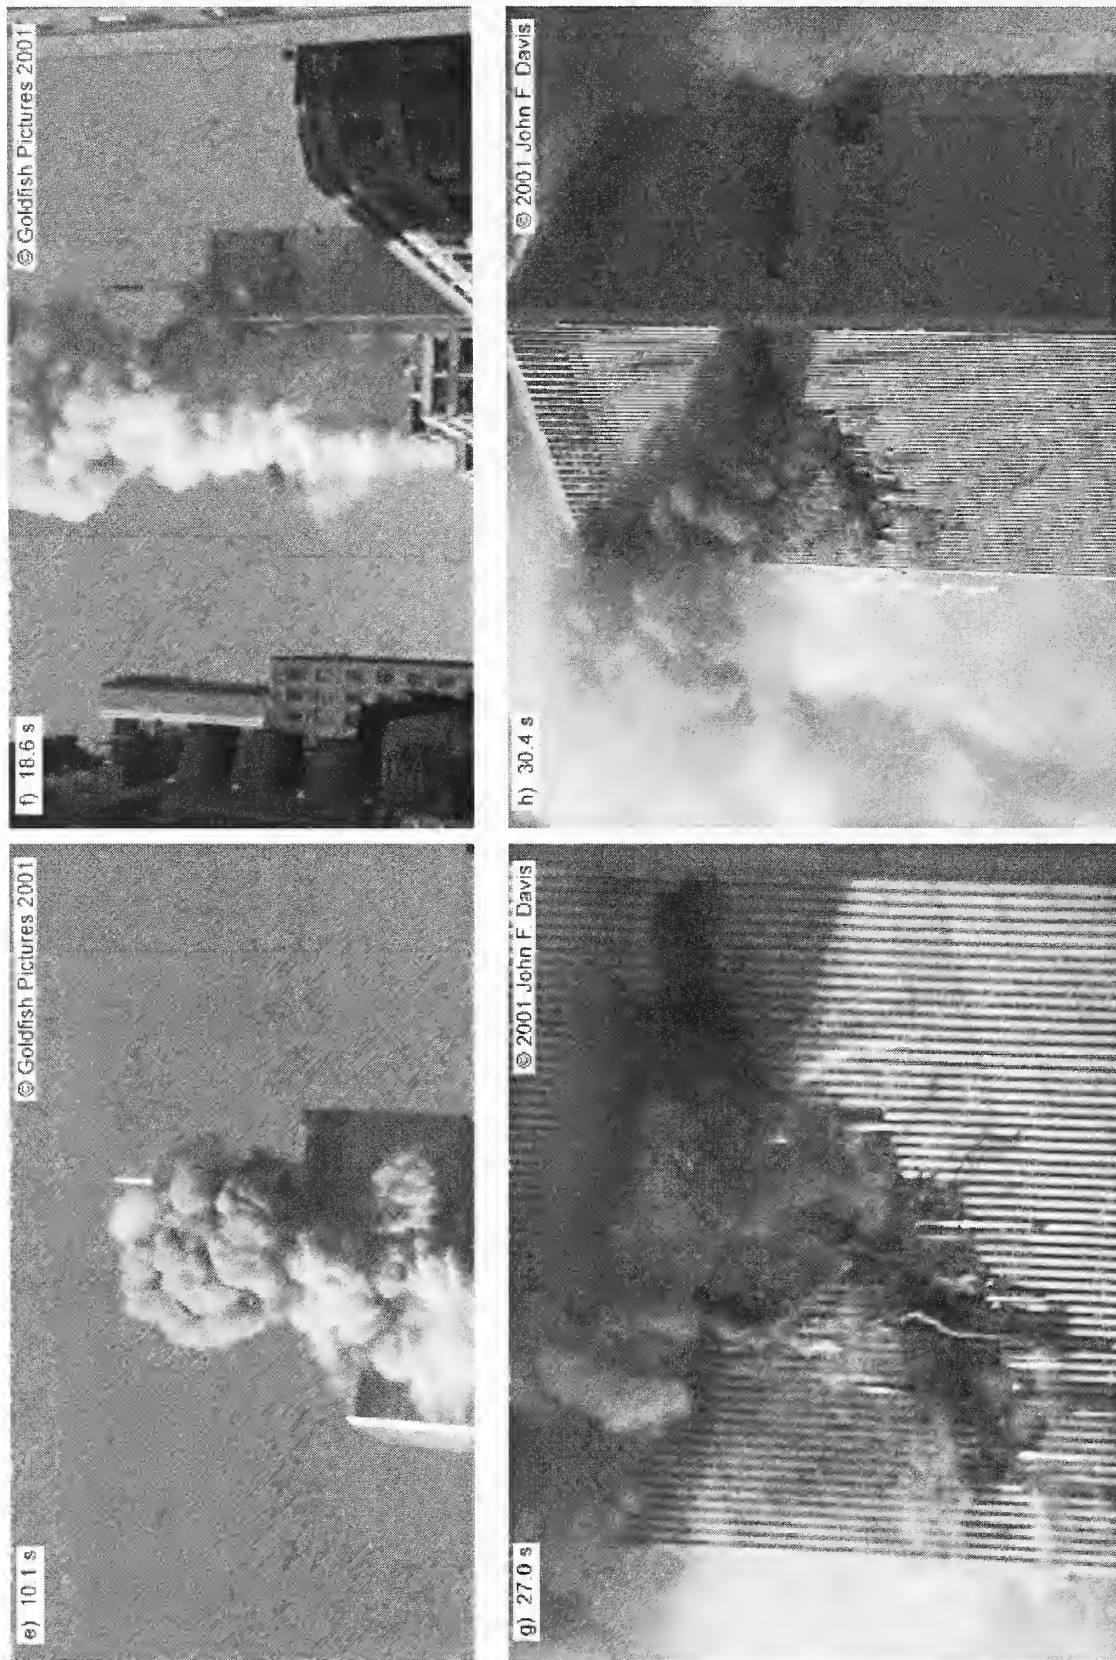
Figure 6–1 shows a sequential series of frames taken from two videos that provides a visual record of the collision and subsequent events. Frame a) in the series was recorded just as the nose of the aircraft struck the tower at 8:46:30 a.m. The second, b), was recorded one frame later and shows a bright flash generated by the collision. This flash was short lived, being observed in only one field of the video (i.e., for 1/60 s).

Roughly 5 s later (frame d), the dust clouds on the north and east faces have grown substantially. The north-face dust cloud is considerably larger, and extensive flames can now be seen throughout the cloud, interspersed with the white dust. A large amount of debris can be seen falling below the aircraft impact location. The prevailing wind has begun to blow the external fireball and falling debris across the north face toward the east. Flames on the east face seem to be present only near the building, suggesting that much less aviation fuel has been expelled on this face. A small region of fire is still visible extending beyond the southern edge of the east face, i.e., apparently coming from the south face of the tower.

At 10.07 s following the aircraft impact (frame e), the fireball that formed on the north face appears to have dissipated, leaving a “thermal” that is continuing to rise. For this report, the word “thermal” is used to identify a mushroom-shaped buoyant plume generated by the rapid release of a large amount of heat. The dust cloud created by debris falling from this face has developed a tube-like appearance and has been blown to the east edge of the tower. A bright region of flame is present across much of the region where the aircraft entered. The dust cloud on the east face has continued to expand, and no flames are now evident within this cloud.

Figure 6-1. A series of frames from videos shows American Airlines Flight 11 striking WTC 1 and the immediate aftermath. Times relative to the aircraft impact time are shown in the upper left-hand corner.

The next frame, (f), was recorded roughly 8.5 s later. At this time the dust-filled cloud sinking below the impact area and the rising thermal created on the north face have been blown further by the wind and are now more than a building width to the east of the northeast corner of the tower. The tube-like cloud of debris extends downward many stories and has developed the appearance of a concentrated vortex. The wind has also blown the debris away from the east face, and this face can now be observed. Substantial fires are now evident on the north and east faces in areas where the dust plumes were initially observed. Even though frame (f) is more zoomed out than frame (e), it is evident that the fire on the north face is much smaller than it was just 8.5 s earlier, suggesting that fires due to the aviation fuel released by the aircraft impact are already beginning to burn out. A thermal can be seen rising behind WTC 1, which provides additional evidence that the south face was damaged by debris passing through the tower.

In the final frame, (h), shown in Figure 6–1, which was recorded 30.37 s after the aircraft impact, the videographer has zoomed out to show the north and west faces of the tower. On the north face flames are still evident in the area of the aircraft impact, and a distinct streamer can also be seen. Smoke is coming from the west face at several isolated positions, but the damage appears to be much less extensive than occurred on the east face, and no flames are evident. A dust plume can be seen near the center of the west face at the top of the building in the vicinity of the mechanical equipment room located on the 108th and 109th floors. Figure A-4 shows that there were several exhaust louvers in this area. A smoke plume is rising from the south face, and smoke seems to be flowing from a location at the southwest corner of the building.

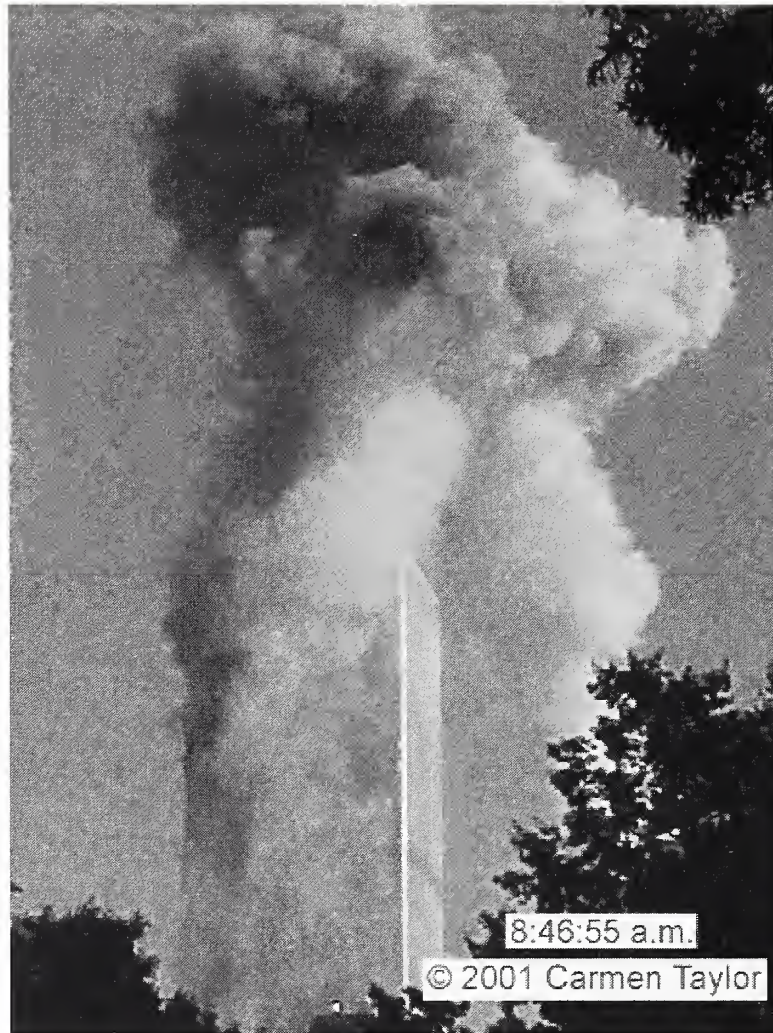
The photograph shows both WTC 1 and WTC 2, with the south face of WTC 1 partially hidden by WTC 2, which is in the foreground. An area of intense fire is apparent on the western side of the south face of WTC 1. This fire is in the vicinity of the 96th floor. An area of falling debris can be seen moving in front of the south face of WTC 2. This debris fell from the south face of WTC 1 and was blown to this location by the prevailing wind. Above the debris cloud a small thermal can be seen rising above the tower. This thermal must have resulted from a fireball that formed on the south face of WTC 2 following the aircraft impact. The occurrence of this fireball is consistent with the area of fire on the south face described above. The formation of a fireball on the south face indicates that a significant amount of aviation fuel from the aircraft passed all the way through the tower and burned on the other side.

Figure 6-2. View of the WTC towers shot at 8:46:55 a.m. from the southeast shortly after American Airlines Flight 11 struck WTC 1. A dust-filled vortex is visible on the right side. A second area of falling debris can be seen passing on the south side of WTC 2. Significant fires are present on the west side of the south face of WTC 1, which can be seen to the left and behind WTC 2.

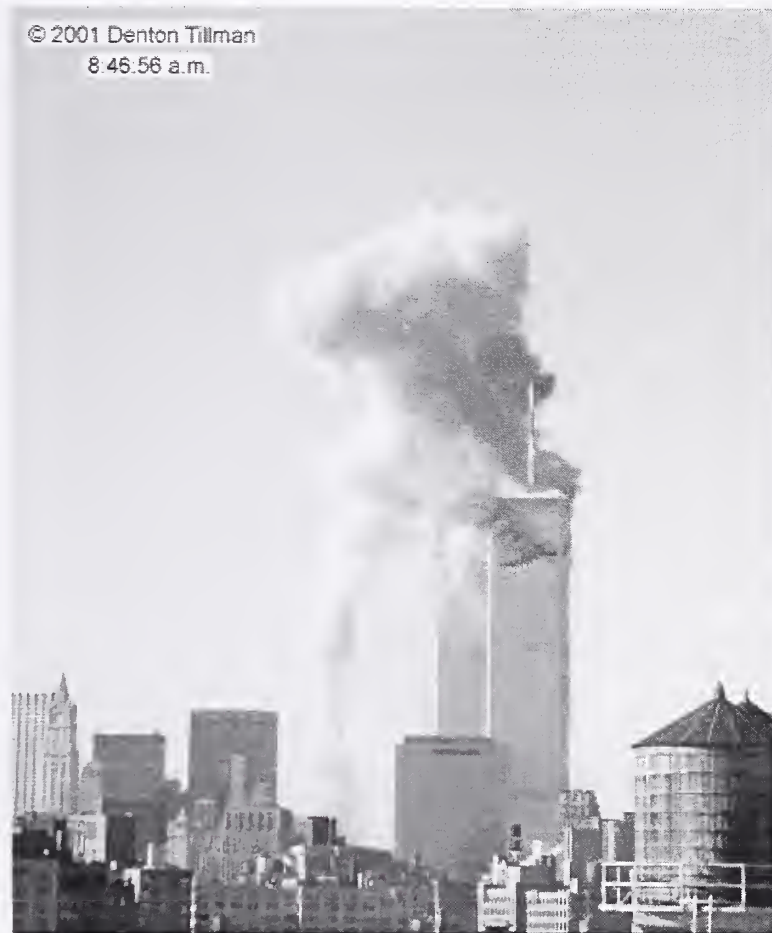
The presence of significant burning on the south face of WTC 1 is also indicated by the photograph shown in Figure 6-3 that was taken 26 s (i.e., 8:46:56 a.m.) after the aircraft impact on the tower. The thermal formed by the fireball on the rear side can be seen behind the large thermal formed by the fireball on the north face. A large amount of smoke is rising from behind the tower, consistent with the heavy fire seen on the south face in Figure 6-2. This photograph also provides an excellent view of the vortex generated on the north face of WTC 1 by the aircraft impact. The vortex is large, extending all the way down to near the ground. It has been transported a large distance by the prevailing wind. Even at this distance, the large fire burning inside the impact cavity in the tower is evident. This is consistent with Figure 6-1 (g), which was recorded at nearly the same time.

Figure 6-3. A cropped photograph taken from the north shows the WTC towers at 8:46:56 a.m., i.e., 26 s after the aircraft impact on WTC 1. Colors have been adjusted.

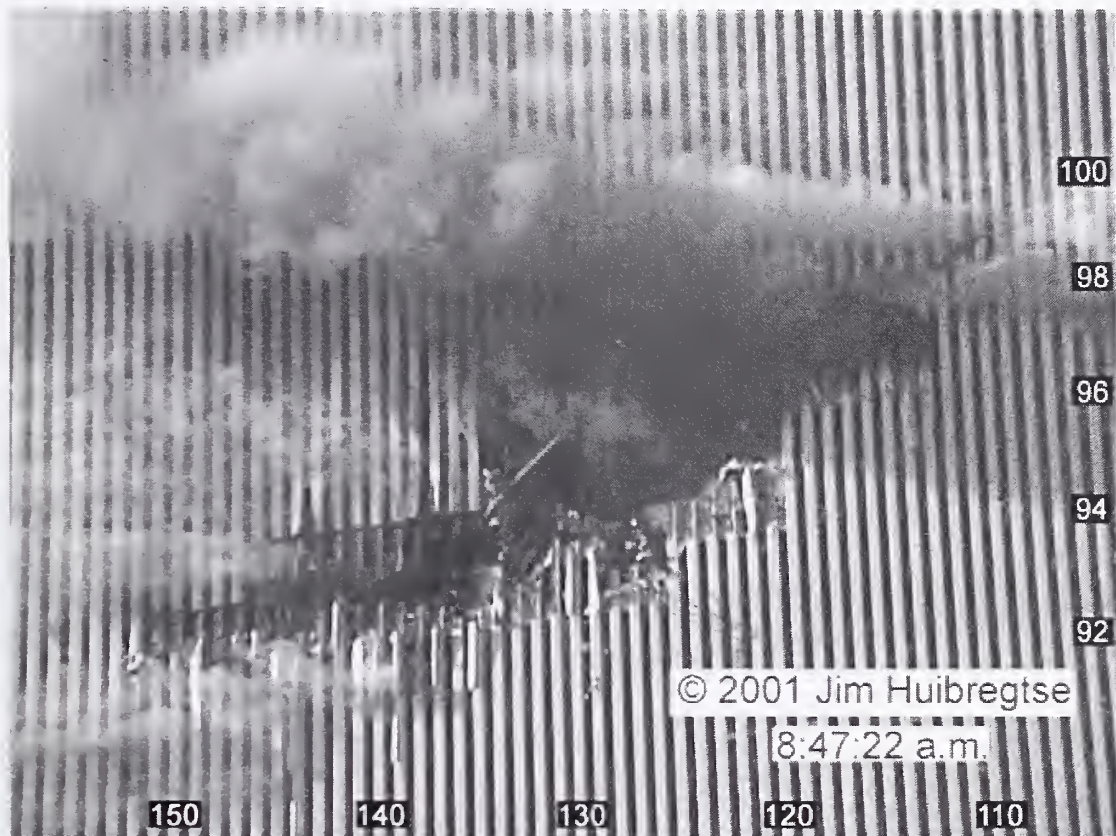
Figure 6-4 shows a relatively close view of the aircraft impact area on the north face of WTC 1 at 8:47:22 a.m., i.e., 52 s after the collision. This image was taken from a video, so the resolution is limited. Figure 6-5 shows another view of the same area taken around 9:30 a.m. Since Figure 6-5 was shot as a photograph on film, the resolution is much higher than in Figure 6-4. Damage to the steel façade and aluminum facing is apparent in both images. Comparison of the two images shows that the appearance of the damaged area is similar in both, which means that images recorded at different times can be used to assess the damage caused by the aircraft impact. By using several high-resolution images, a detailed façade map of the damage to the perimeter wall of the tower caused by the aircraft impact was prepared.

By inspection of Figure 6-4 and similar images, it was observed that the wing tips and the top of the vertical stabilizer at the tail of the aircraft damaged the aluminum column covers on the steel façade without cutting through the steel below or completely removing the covers. Using these images, it was possible to map out locations on columns where the wingtips and the vertical stabilizer struck the tower. These locations were then transferred to the representation of the damaged steel façade shown in Figure 6-6 and are represented by dashed lines, with wings to the right and left and the vertical stabilizer in the center. The good agreement between the damage pattern and the wing-tip locations is evident. It was reported in the FEMA report (McAllister 2002) and widely in the media that American Airlines Flight 11 struck floors 94 to 98 of WTC 1. The dotted horizontal lines on the left side of Figure 6-6 indicate the locations of concrete floor slabs. It can be seen that while the tip of the left wing of the aircraft struck very close to the base of the 94th floor, the wing end marked column 153 at the very top of the 93rd floor. It is evident from the Figure that the right wing actually struck well up on the 99th floor on column 109. The impacted floors therefore range from the 93rd floor to the 99th floor.

Figure 6-4. This image of the north face of WTC 2 is a frame taken from a video recorded at 8:47:22 a.m. Column and floor numbers have been added.

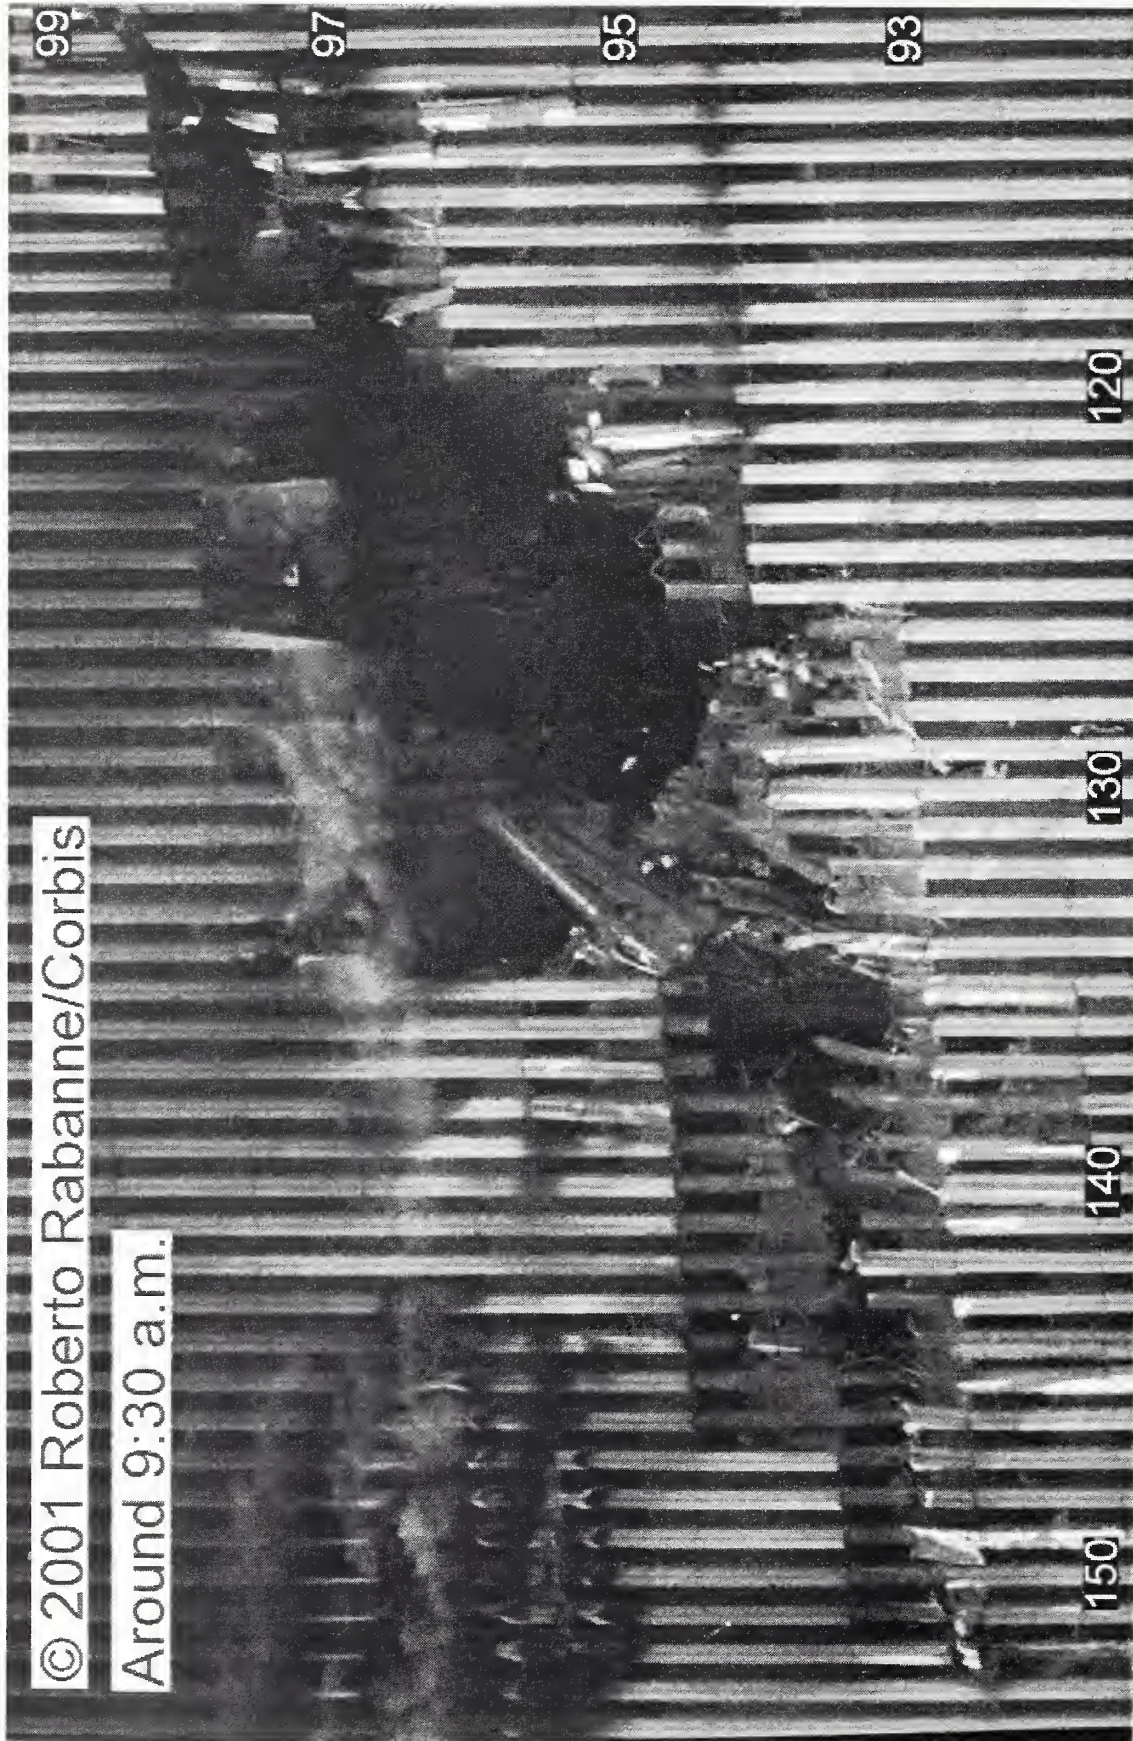
Figure 6-5. A close-up image of the north face of WTC 1 recorded around 9:30 a.m. shows the area of WTC 1 where the aircraft impacted. Column and floor numbers have been added.

From Figure 6-5 and Figure 6-6 it can be seen that the passage of the aircraft through the north face façade broke out two complete steel panel sections (columns 126 to 128 and columns 132 to 134 extending from the middle of the 94th floor to the middle of the 97th floor) as well as portions of several other panel sections. Most likely these were pushed into the building, since there is no visual evidence that they landed on the ground. The end of one of these panel sections can be seen sticking out of the building at the bottom of the opening in the figures.

It is evident from Figure 6-4 and Figure 6-5 that substantial areas of the concrete floor slabs for the 95th through 97th floors were destroyed in the immediate vicinity of the aircraft impact location. There is a large open area in the impact region in which no floor slabs are visible. A substantial section of collapsed floor slab is apparent in the enlarged portion of Figure 6-5 shown in Figure 6-8. One of the trusses (indicated by an arrow) that supported the floor slab and the corrugated sheet metal on which the concrete was poured are visible. The floor slab section appears to have collapsed from above and is at least 17 ft wide. No visual material has been identified that allows the depth into the building of the floor removal and damage to be determined (it is apparently too dark to see inside), but it clearly extends many feet.

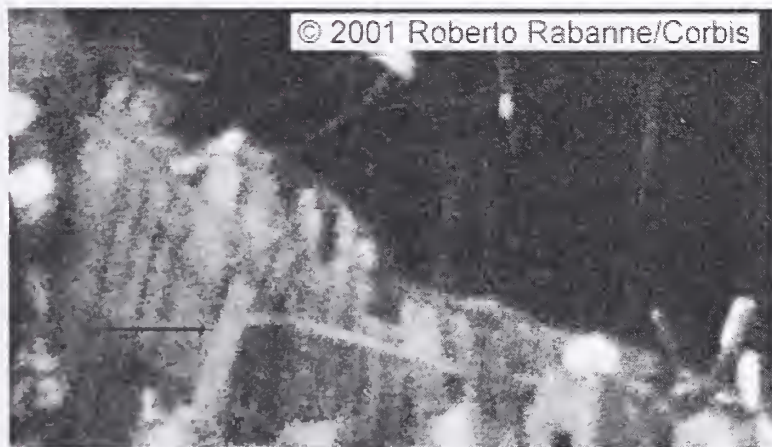
Figure 6-8. An enlarged and enhanced portion of Figure 6-5 shows a portion of one of WTC 1's floor slabs that has collapsed into the opening created by the aircraft impact. The corrugated steel on the bottom of the floor slab and a portion of one of the support trusses (indicated by an arrow) can be seen.

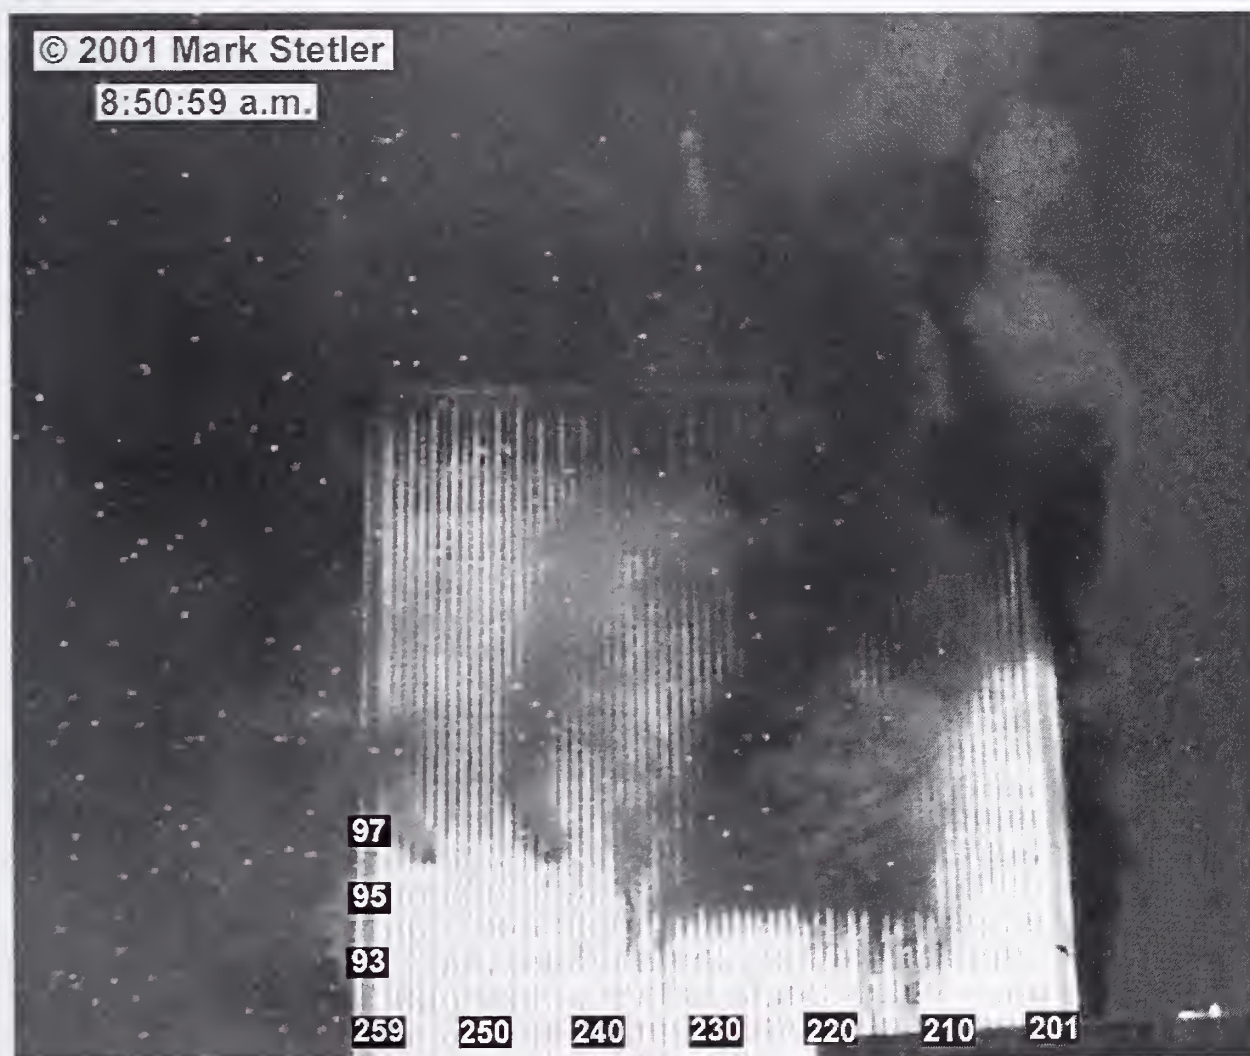
Figure 6-10 shows a photograph of the east face of WTC 1 taken roughly four and a half minutes after the aircraft impact. It looks similar to more distant videos that were recorded very shortly after the event, suggesting that the appearance of this face has not changed significantly since the aircraft impact. Figure 6-11, which also looks similar, was taken just over a minute later and provides a closer view. Numbers indicating floors and columns have been added to both figures for reference.

Figure 6-10. Photograph showing the east face of WTC 1 recorded at 8:50:59 a.m. Column and floor numbers have been added.

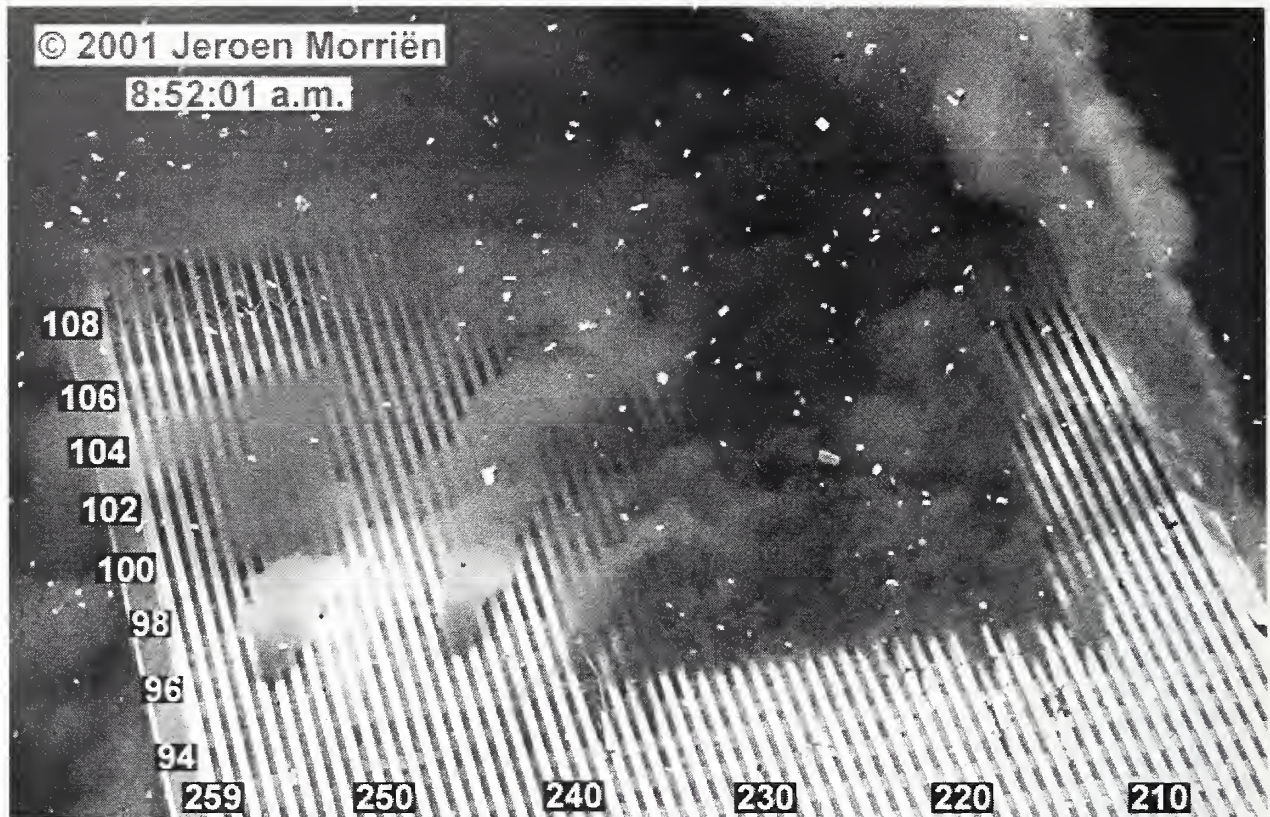
The most prominent feature in Figure 6-11 is a long line of smoke on the 94th floor extending from roughly window 94-210 to window 94-237, or a distance of nearly 90 feet. Clearly, all of the glass in the windows over this length has been broken out. Closer inspection shows that several of the aluminum covers on these columns have been partially dislodged as well. Most are near the right edge of the region, but the cover for column 94-237 has been nearly removed. Two covers, for columns 94-213 and 94-216, are missing completely. The aluminum cover on the northeast corner for this floor has also been partially

displaced. This proved to be an easily recognized marker for the floor. Isolated windows at 94-241 and 94-250 are also missing.

Figure 6-11. Photograph of the east face of WTC 1 taken at 8:52:01 a.m. The photograph has been enhanced and cropped. Floor numbers are indicated along the left edge of the building and column numbers along the bottom of the photo.

Some damage and missing window glass are present on lower floors that were not directly impacted by the aircraft. Window glass has been broken out and some column covers have been displaced or removed completely on the 93rd floor from columns 93-209 to 93-216 as well as columns 93-219 and 93-220. The glass for window 93-237 is missing, and the aluminum cover for column 93-237 has been displaced. Damage is also apparent on the 92nd floor, where windows 92-212 and 92-213 have been broken out. A chair is stuck in window 92-212, and the aluminum cover on column 92-212 has been removed. Covers on columns 92-216 and 92-217 have been displaced, and the window glass between these two columns is missing. On the 91st floor, the covers on columns 91-213, 91-214, and 91-216 have been displaced, and windows 91-213 and 91-216 are open. There is no apparent damage lower than the 91st floor.

Portions of the east face above the 94th floor are hidden by the smoke rising from this floor. Only minimal damage is seen on these higher floors, including a displaced column cover and missing window glass at window 95-237 and two broken windows on the 96th floor at windows 96-243 and 96-254. All window glass and column covers to the north of column 209 appear to be undisturbed.

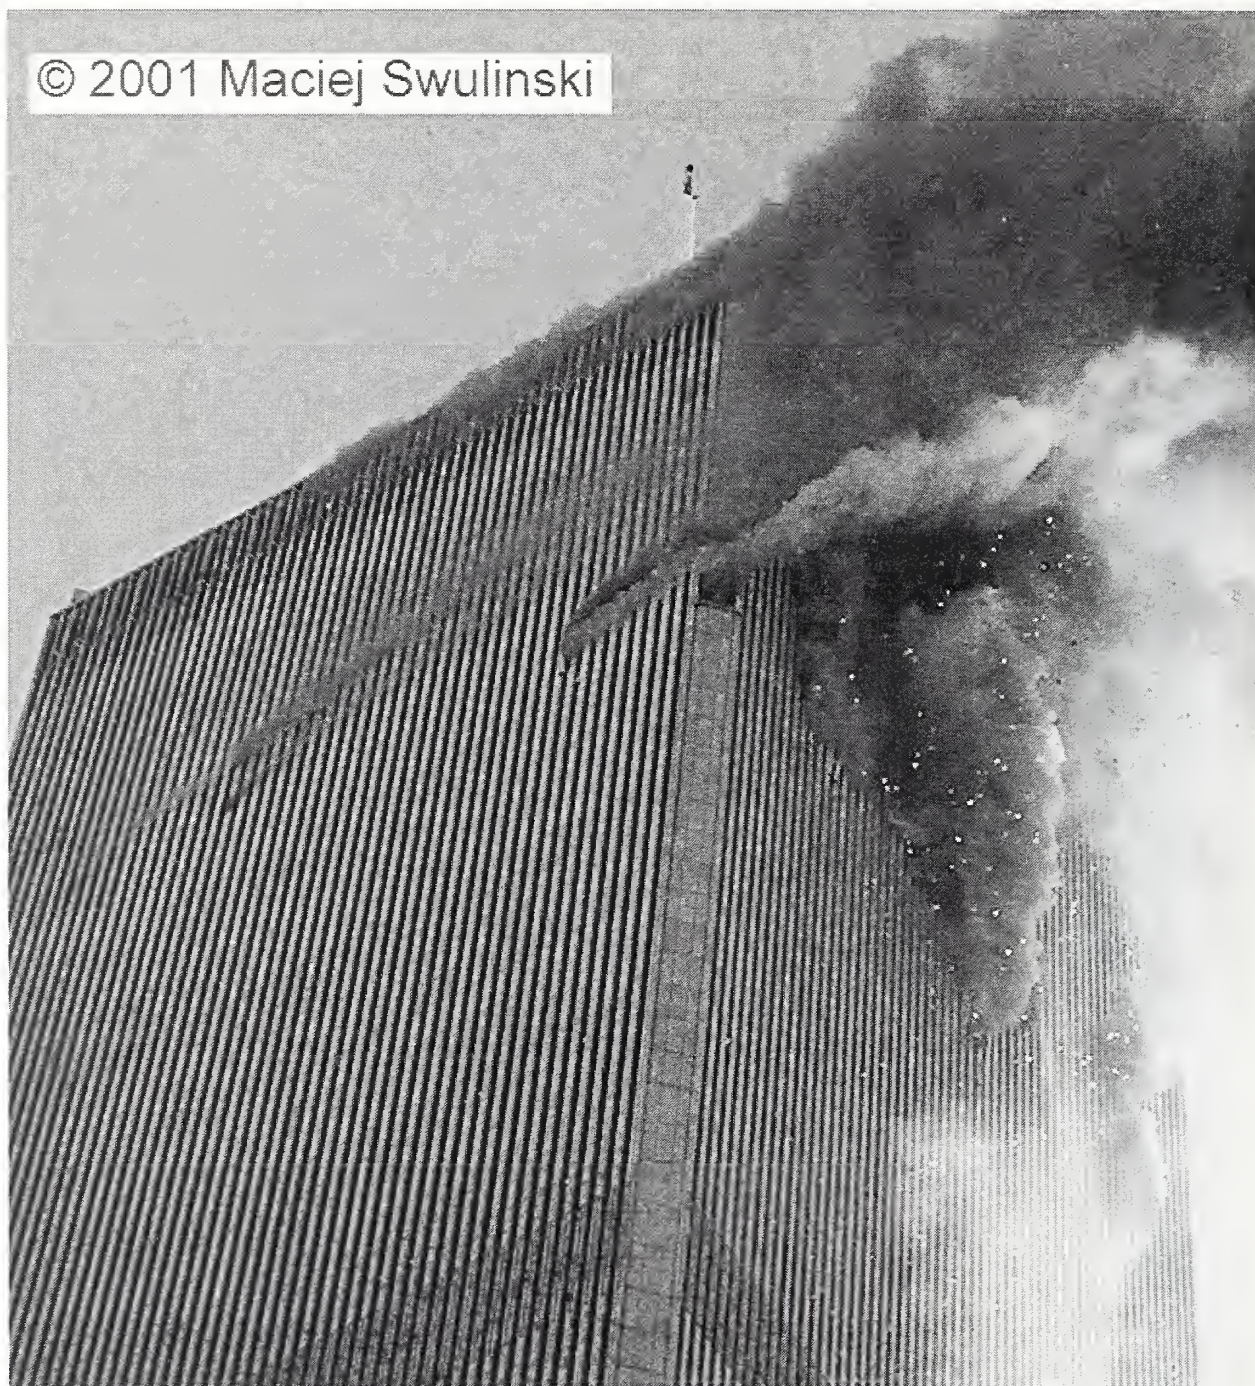
In contrast to the relatively large number of windows missing on the east and south faces of the tower, the number of windows initially opened on the west face was considerably less. This can be seen in Figure 6–12, which shows the west face shortly after the aircraft impact. The façade maps for window condition on the west face shown in Figure 6–9 is based on a number of photographs and videos and indicates that nine windows were broken open on this face by the aircraft impact and fireballs. The only obvious damage to the aluminum facing occurred on columns 410 and 411 at the 96th and 97th floors. The covers for column 410 were removed on both floors, while those on column 411 were partially dislodged.

Figure 6-12. A cropped photograph shows the west and south faces of WTC 1 shortly after the aircraft impact. The image has been enhanced by adjusting the intensity levels. The exact time of the image is unknown, but the appearance suggests that it was taken within two minutes of the aircraft impact.

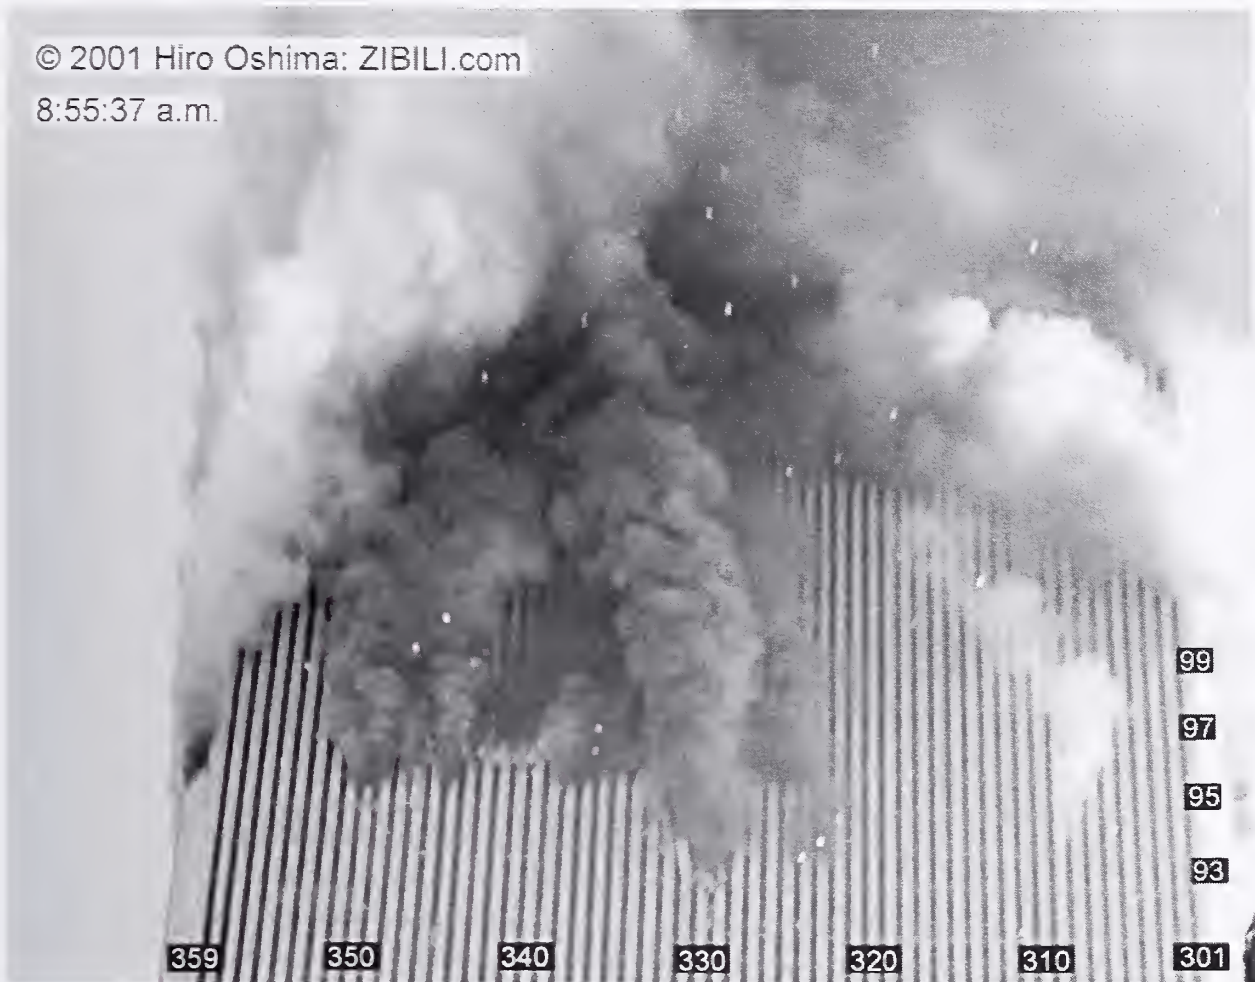
A prominent feature in both photographs is the missing aluminum cover on the southwest corner of WTC 1 at the 96th floor. Heavy smoke is flowing from this opening. This missing cover is easily recognized and provides a quick reference for identifying the tower, face, and floors in visual material. In addition to the missing corner, some of the aluminum column covers on the face have been displaced. Using the corner marker as a guide, it is apparent that most of the smoke seen issuing from broken windows on the south face is coming from the 95th and 96th floors on the western side. Only a single window (94-308) to the east of column 322 appears to be broken open. There is an area of heavy smoke at the center of the face coming from lower down on the 93rd floor. Comparison of a number of photos and videos taken during the event showed that the smoke released from this point remained heavy until the tower collapsed. It was never possible to get a clear view of the damage in the immediate vicinity. As discussed further in Section 6.4.3, it is believed that the damage in this area was the result of the removal of a complete three story steel panel section from the face.

Figure 6-13. This enhanced and cropped photograph shows the south face of WTC 1 at 8:55:37 a.m. Column and floor numbers have been added.
